**MERRIMACK RIVER BASIN
NEW DURHAM, NEW HAMPSHIRE**

**MERRYMEETING LAKE DAM
NH 00342**

**PHASE I INSPECTION REPORT
NATIONAL DAM INSPECTION PROGRAM**

OCTOBER 1978

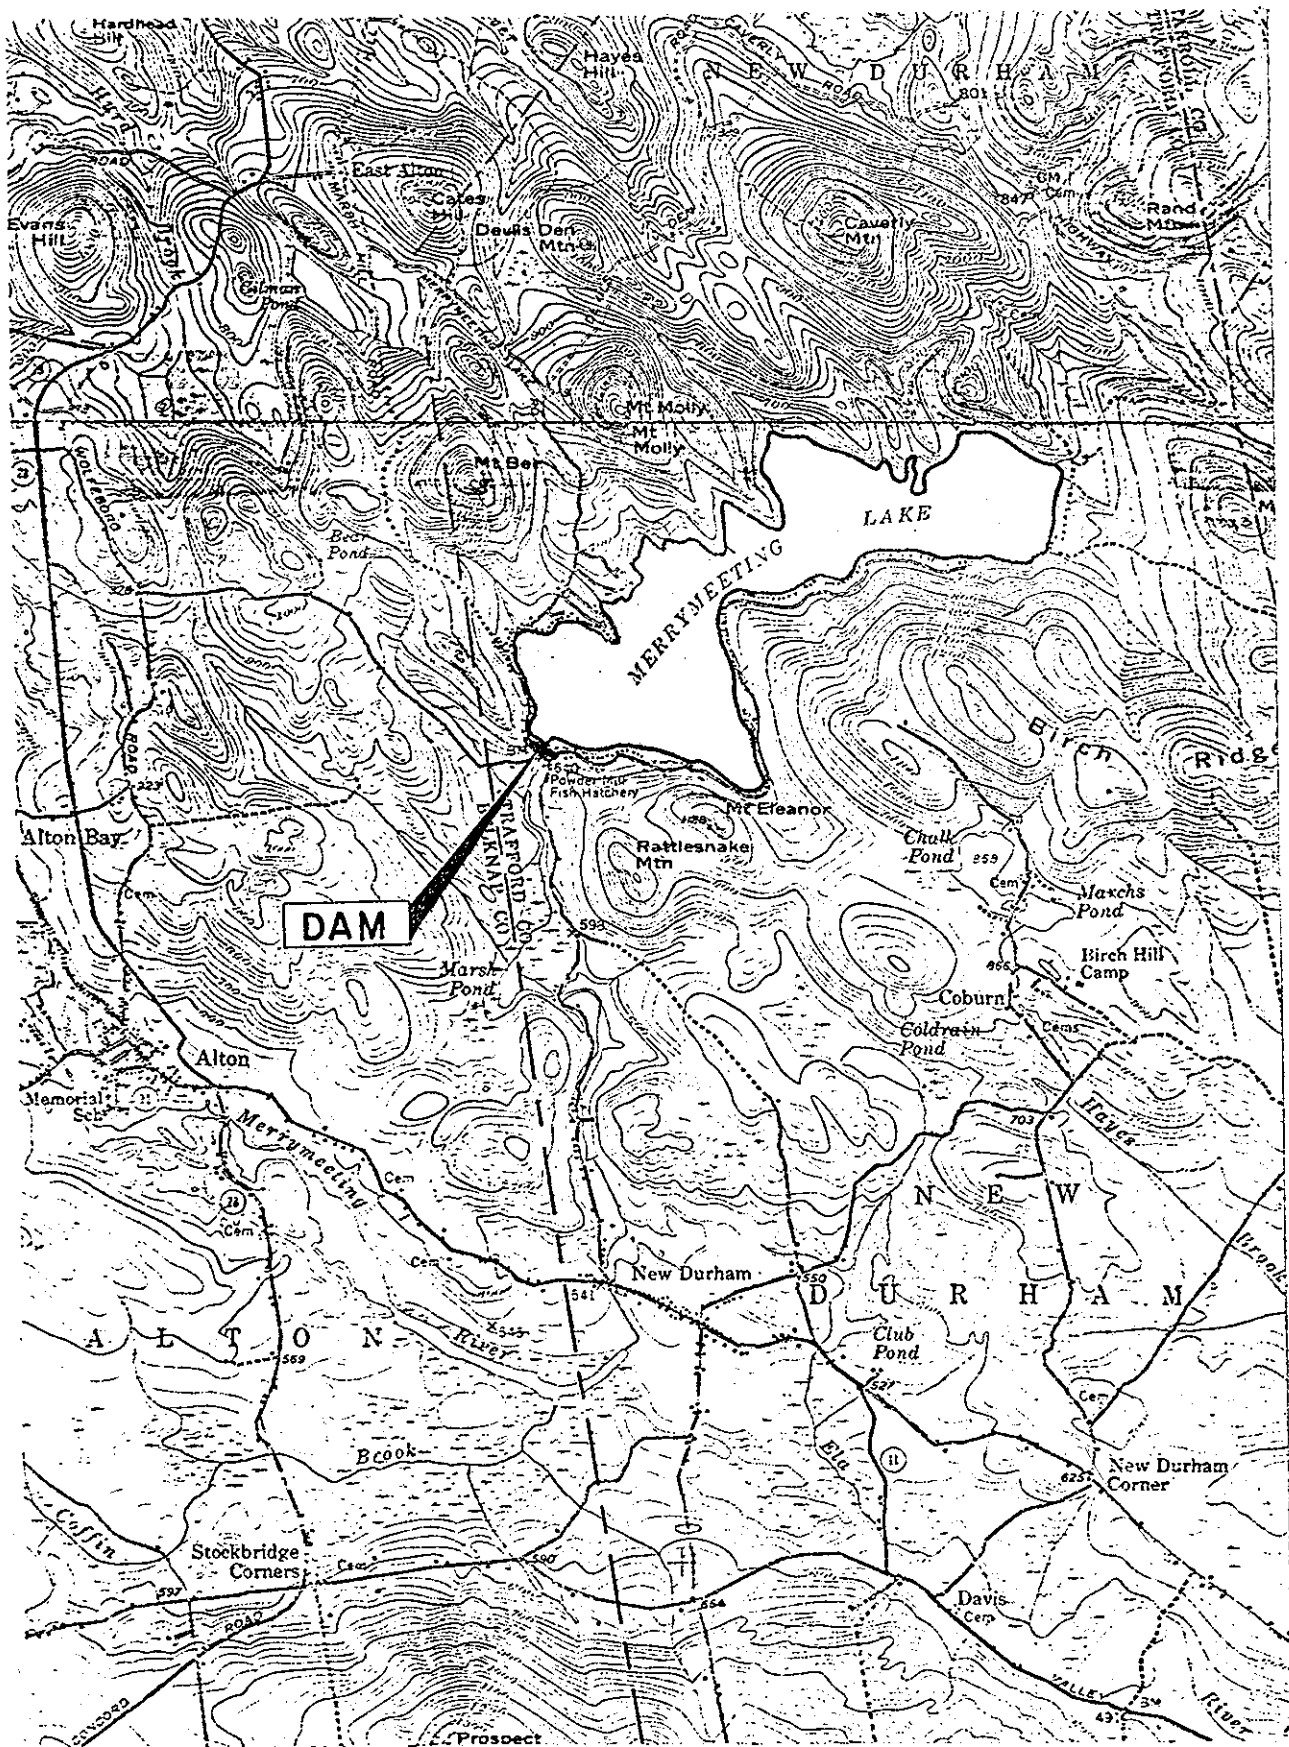
View of the dam from the downstream side. The low level outlet gate house is in the center. The zone of seepage is demarcated by the end of the cut grass area and the swamp-type vegetation below it.

A zone of seepage was observed in the downstream face of the embankment, approximately 11 feet below the top of the embankment and extending from a point about 54 feet to the right of the low level outlet continuously to a point about 36 ft. to the left of the outlet. The seepage was clean at the time of the inspection. While a considerable quantity of water was observed, an accurate estimate of the seepage could not be made due to the extent of the zone. A measurement made in March 1965, however, records the seepage as being 79 gpm, based on a stream gauge at the Powder Mill Fish Hatchery.
